Permit Application Numbers

SAJ-1996-02987 (NW-DCM):	Restoration of main island dock and causeway (MT)
SAJ-2015-02256 (NW-DCM):	Restoration of Magueyes Island main entrance concrete dock (MB)
SAJ-2015-02257 (NW-DCM):	Restoration of wooden dock at the northern coast of Magueyes Island (MQ)
SAJ-2015-02258 (NW-DCM):	Restoration of L-shape wooden dock and associated dive shack (Dock G)
SAJ-2015-02260 (NW-DCM):	Restoration of wooden dock at the western coast of Magueyes Island (MBP-1)
SAJ-2015-02265 (NW-DCM):	Restoration of small wooden dock at the western coast of Magueyes Island (MBP-2)
SAJ-2015-02266 (NW-DCM):	Restoration of Wooden dock at the southwestern coast of Magueyes Island (MA)

Modified Croquis of Magueyes Island and Photos of Dock Facilities (UPRM)

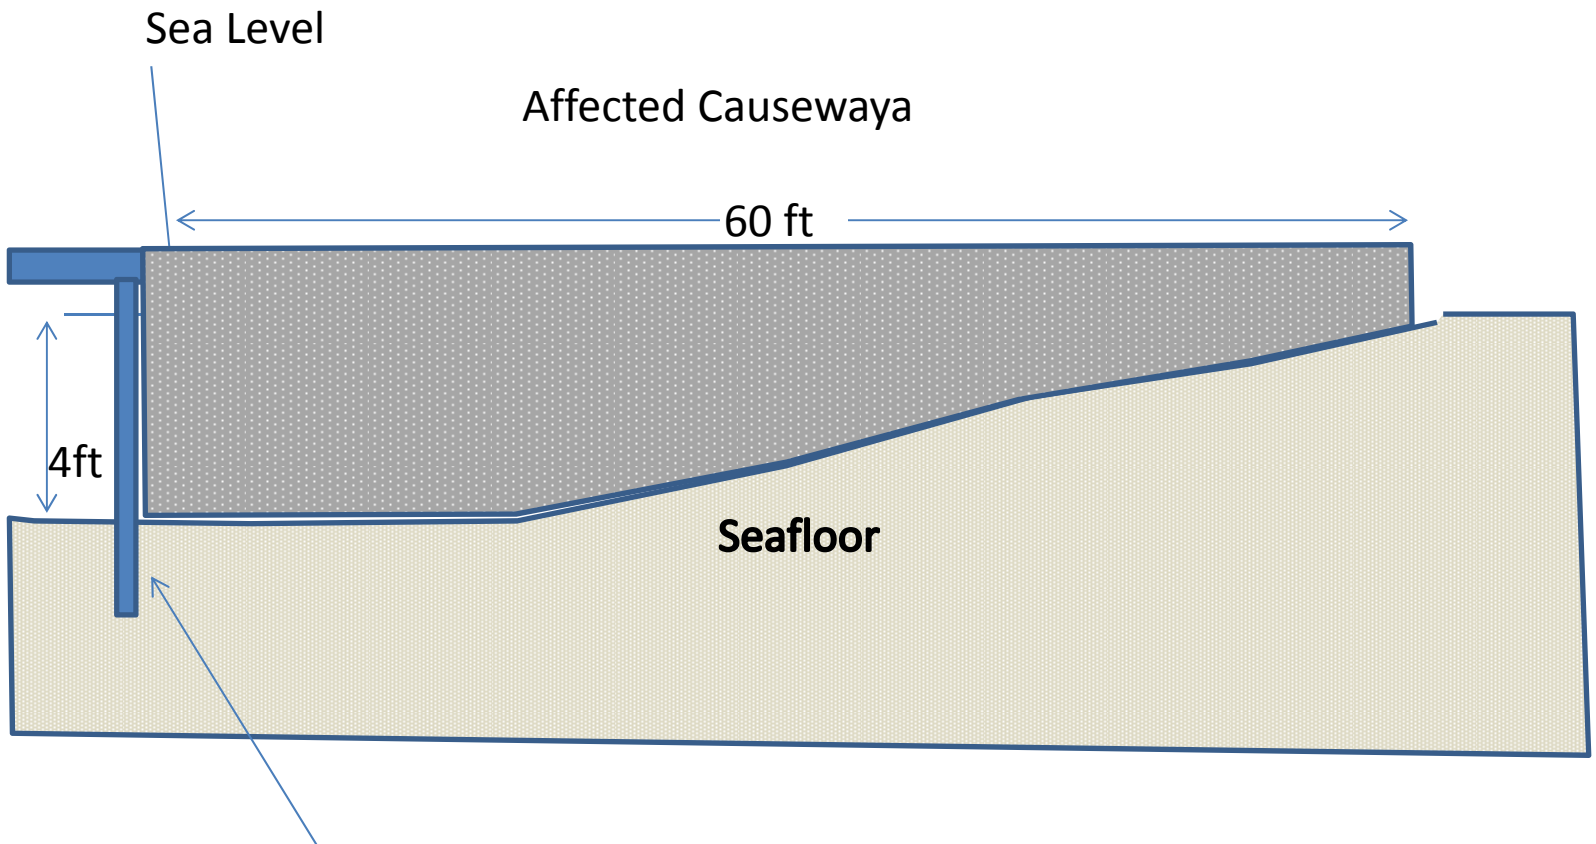
Side-view (A). Looking Westward into affected causeway at MT, present condition. The footing of the retaining wall was affected due to increased propeller wash and it had collapsed as indicated in the photos. Approximate locations in the wall are indicated.

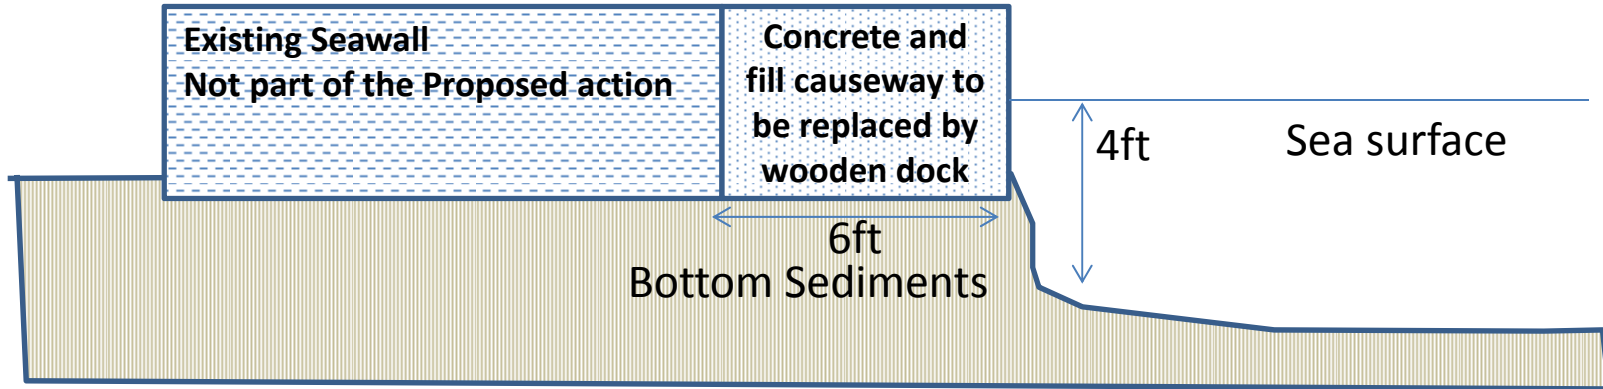
Side view B. Present day conditions, Northward view of Concrete Causeway. Depth varies from 0-4ft, approximately)

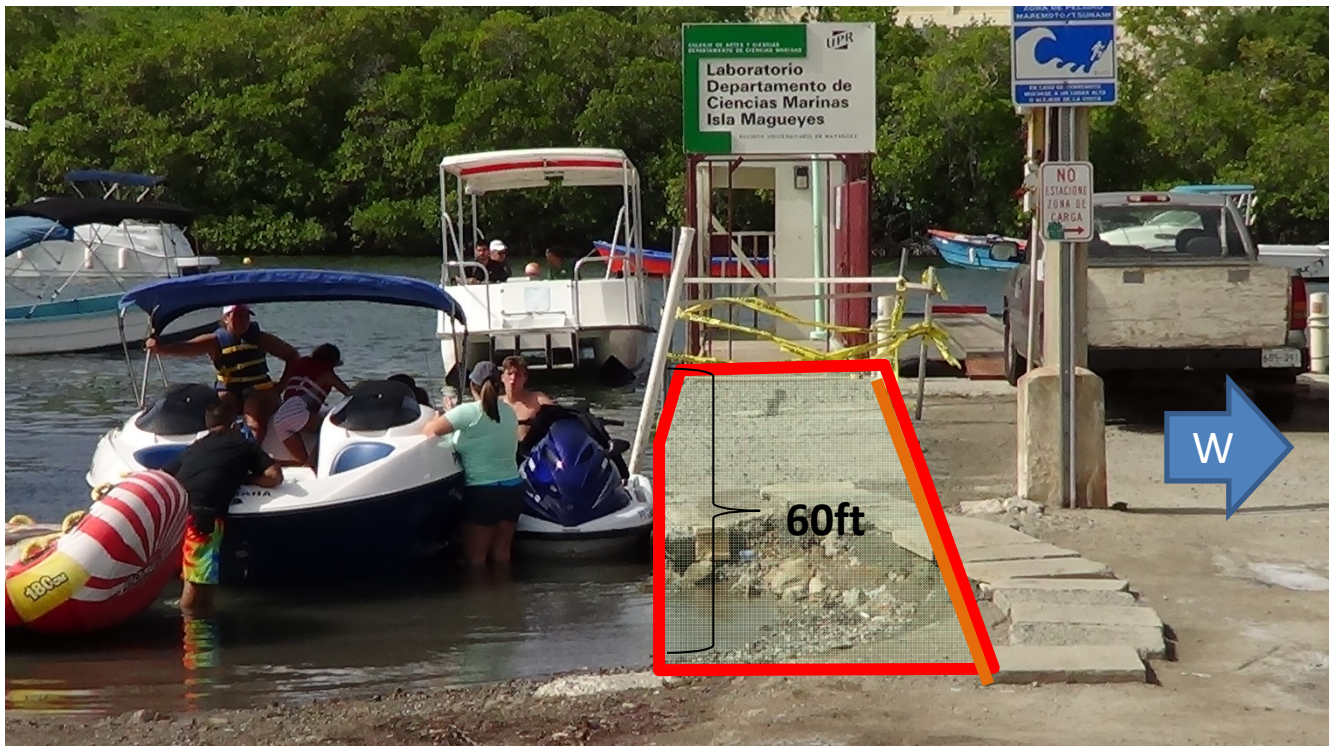
SAJ-1996-02987 (NW-DCM): Restoration of main island dock and causeway (MT)

The area delineated in red shows eroded causeway area associated with dock MT proposed to be substituted by a wooden dock. A retainer wall will be constructed under the orange line.

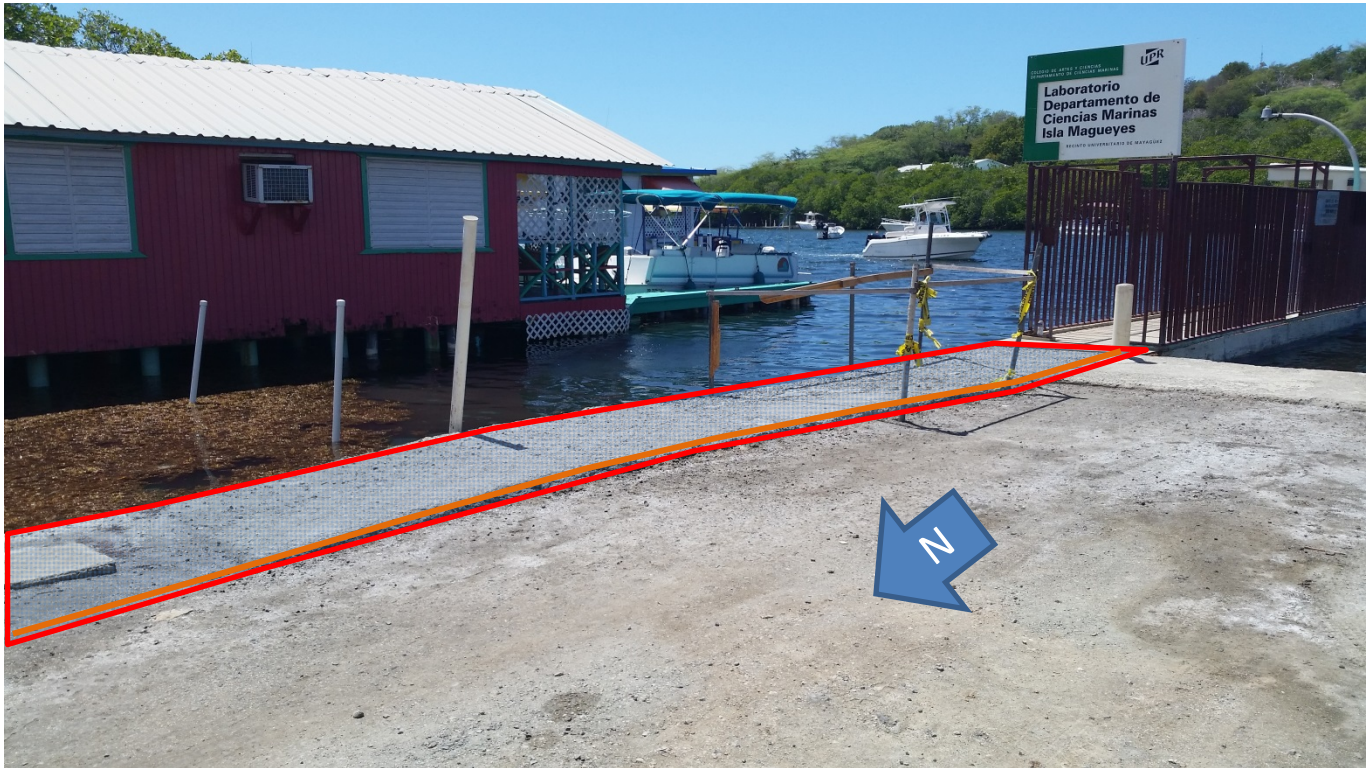
SAJ-1996-02987 (NW-DCM): Restoration of main island dock and causeway (MT)

The area delineated in red shows the top of the causeway area associated with dock MT proposed to be substituted by a wooden dock. A retainer wall will be constructed under the orange line.

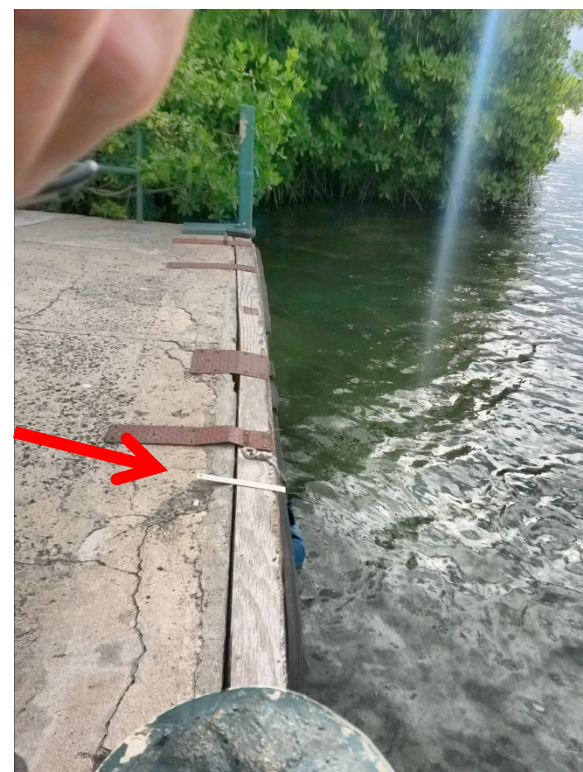
View F; MB. Lateral Photograph showing the top of the wooden damper that is proposed to be replaced. No in-water work is going to be needed. And the same dimensions will be used. The red arrow shows a 1ft ruler.

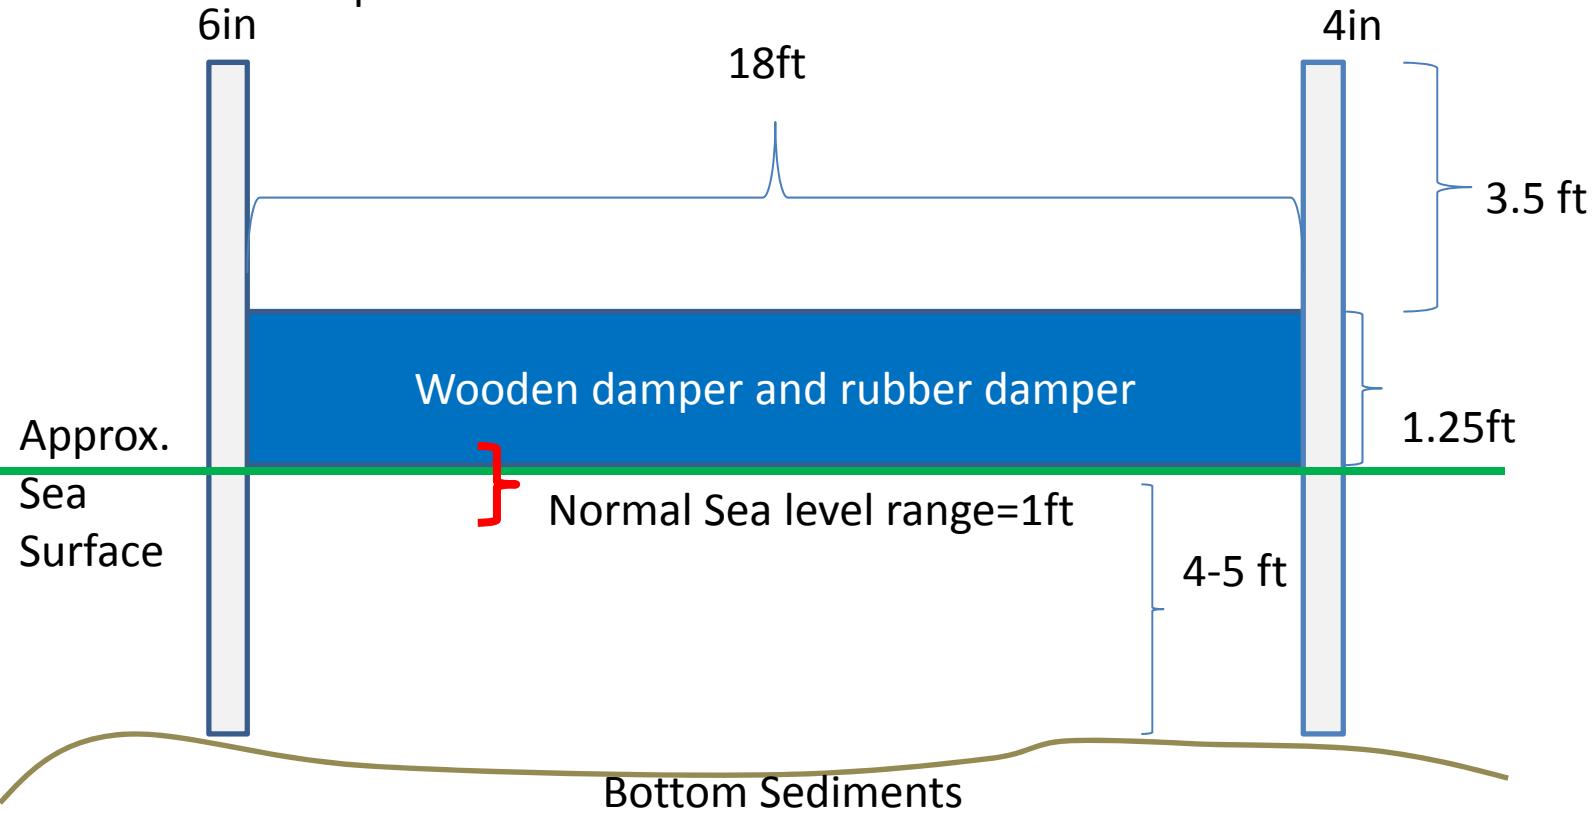
Southerly (front) View of Muelle Botero (MB). Wooden damper is shown in blue.

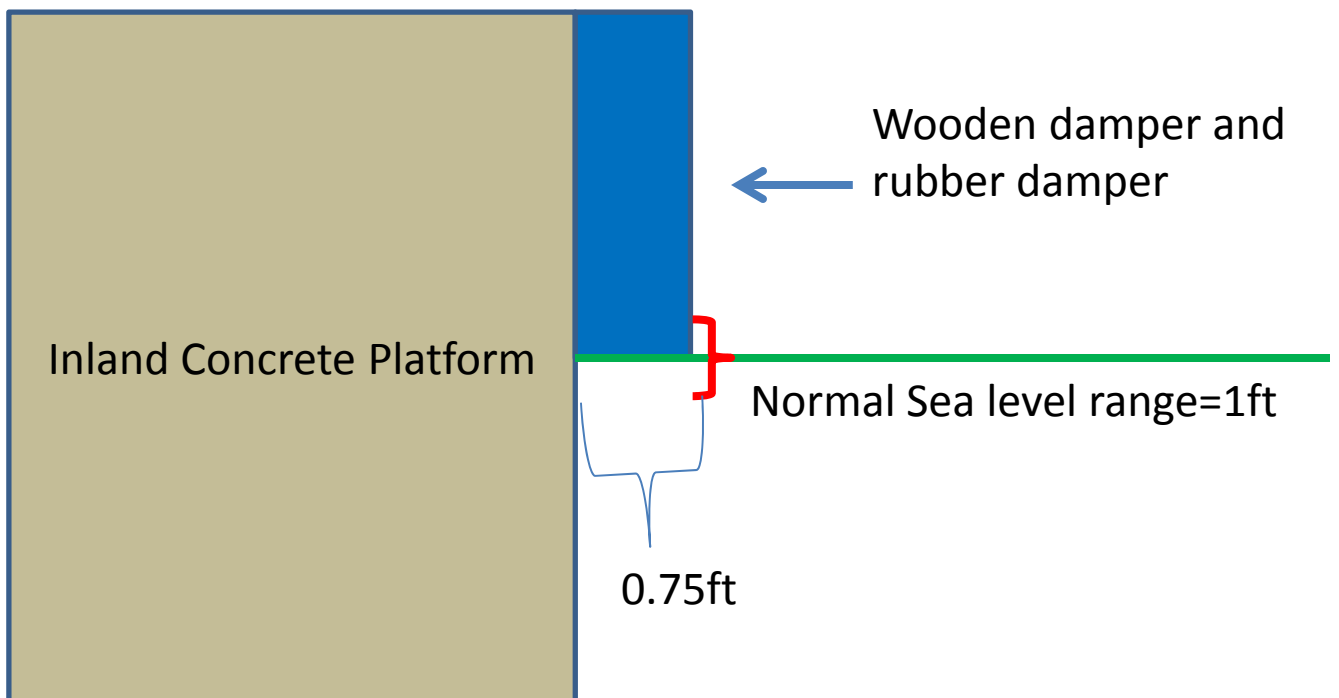
Westerly (side) view of Muelle Botero (MB). Wooden damper shown in blue

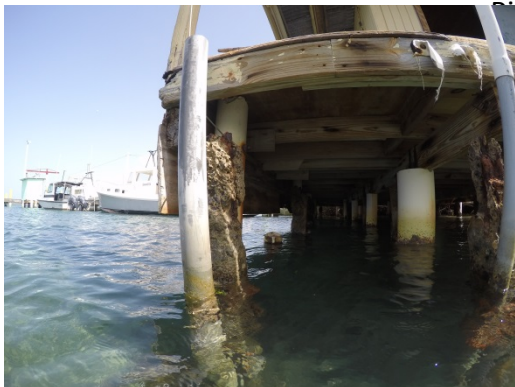
Northward View
Showing deteriorated
condition of cement
piling

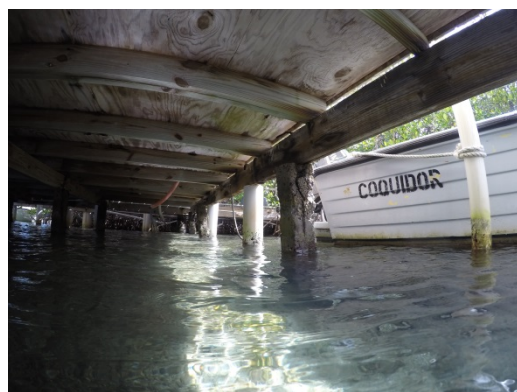
Northeastward View,
under the diveshack
Showing the deteriorated
condition of cement
pilings

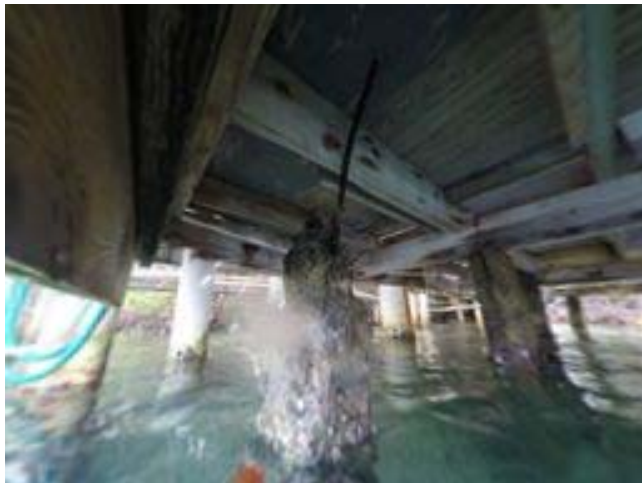
Diagonal View to the Northeast Showing the deteriorated condition of cement pilings

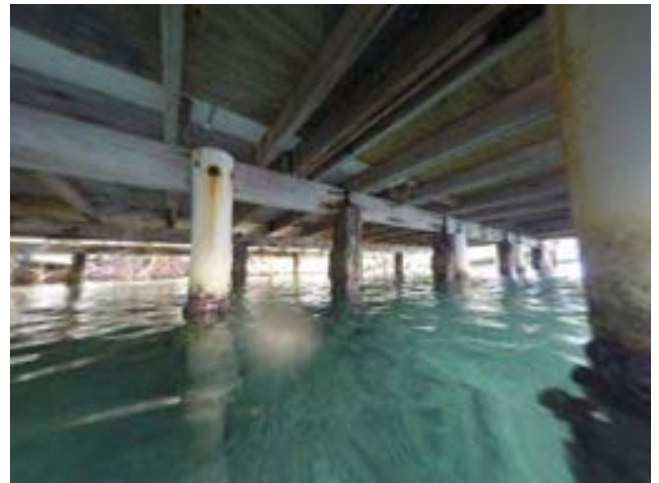
Diagonal View to the Southeast Showing the deteriorated condition of cement pilings
