Permit Application Numbers

SAJ-1996-02987 (NW-DCM):	Restoration of main island dock and causeway (MT)
SAJ-2015-02256 (NW-DCM):	Restoration of Magueyes Island main entrance concrete dock (MB)
SAJ-2015-02257 (NW-DCM):	Restoration of wooden dock at the northern coast of Magueyes Island (MQ)
SAJ-2015-02258 (NW-DCM):	Restoration of L-shape wooden dock and associated dive shack (Dock G)
SAJ-2015-02260 (NW-DCM):	Restoration of wooden dock at the western coast of Magueyes Island (MBP-1)
SAJ-2015-02265 (NW-DCM):	Restoration of small wooden dock at the western coast of Magueyes Island (MBP-2)
SAJ-2015-02266 (NW-DCM):	Restoration of Wooden dock at the southwestern coast of Magueyes Island (MA)

Modified Croquis of Magueyes Island and Photos of Dock Facilities (UPRM)

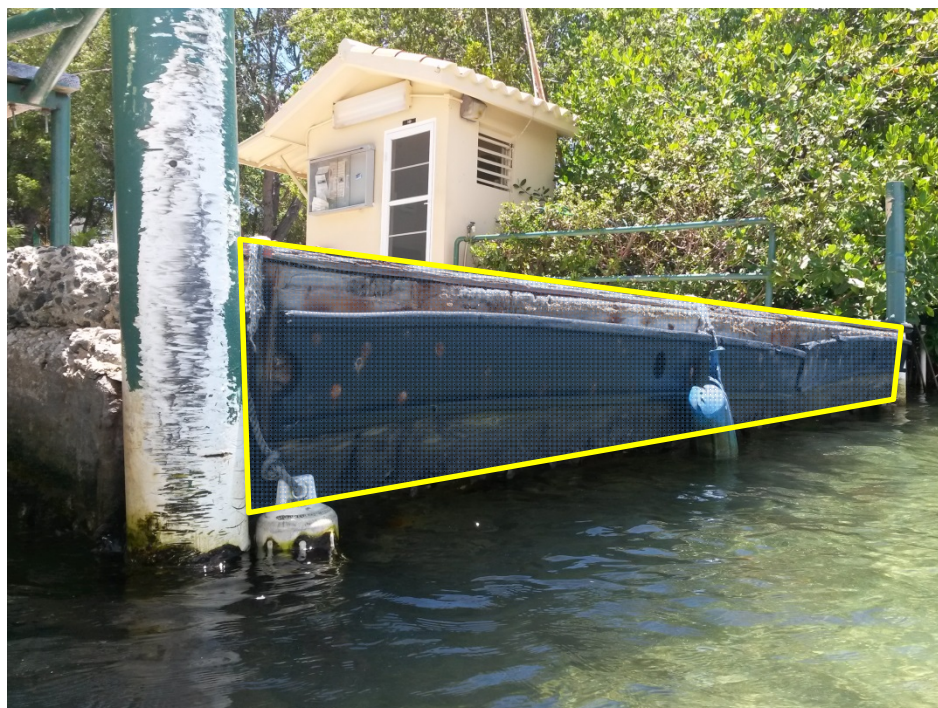
View E; MB

View F; MB. Lateral Photograph showing the top of the wooden damper that is proposed to be replaced. No in-water work is going to be needed. And the same dimensions will be used. The red arrow shows a 1ft ruler.

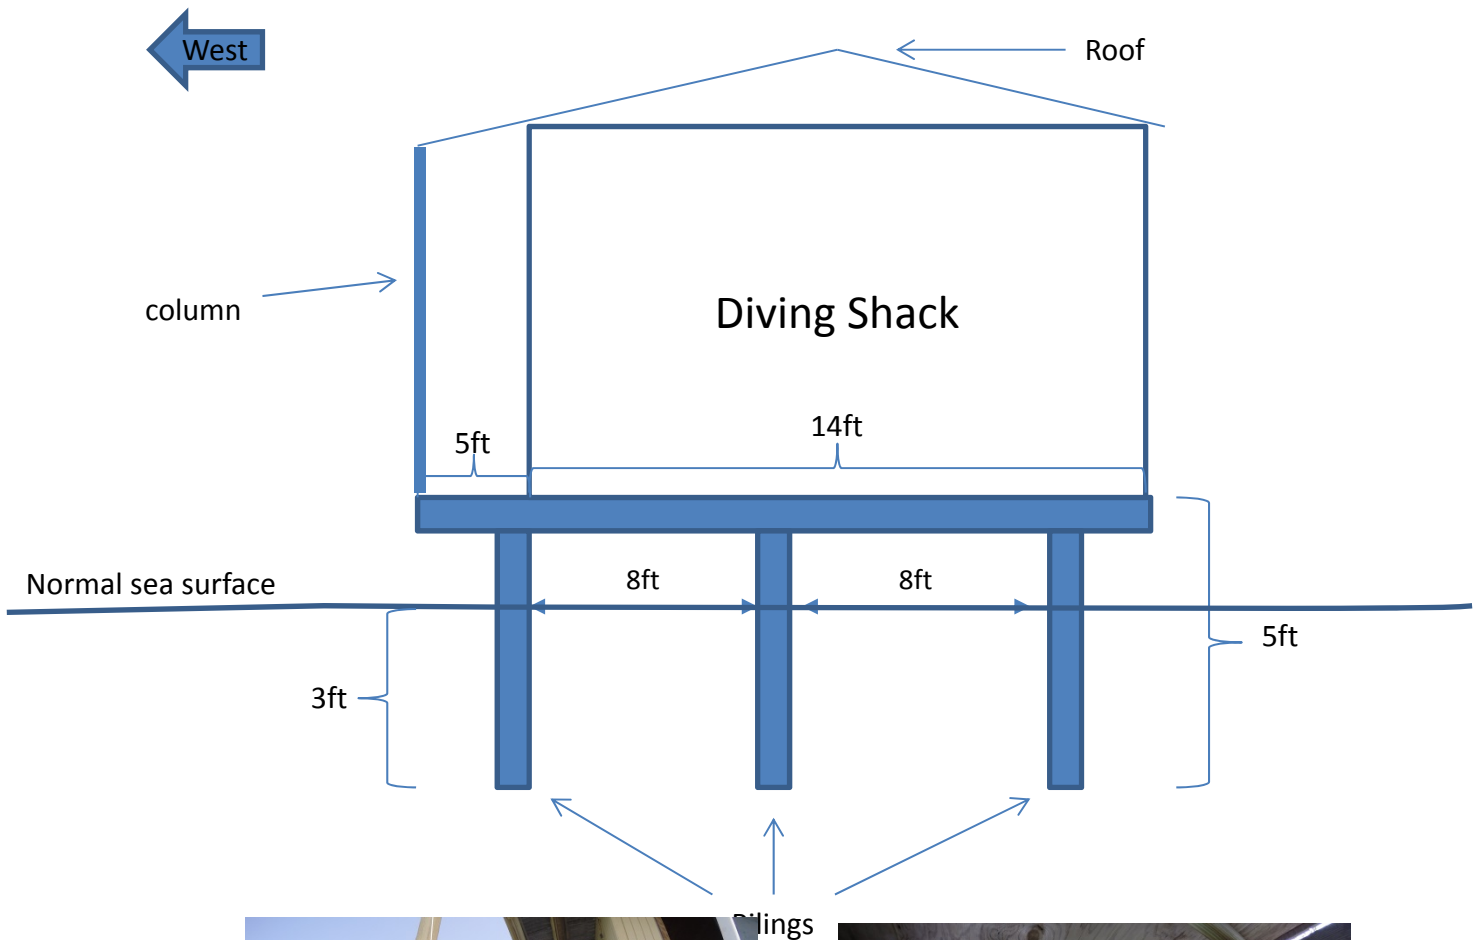
Side view C. North is into the page. Three pilings represent each 4 pilings oriented into the page.

Northward View
Showing deteriorated
condition of cement
piling

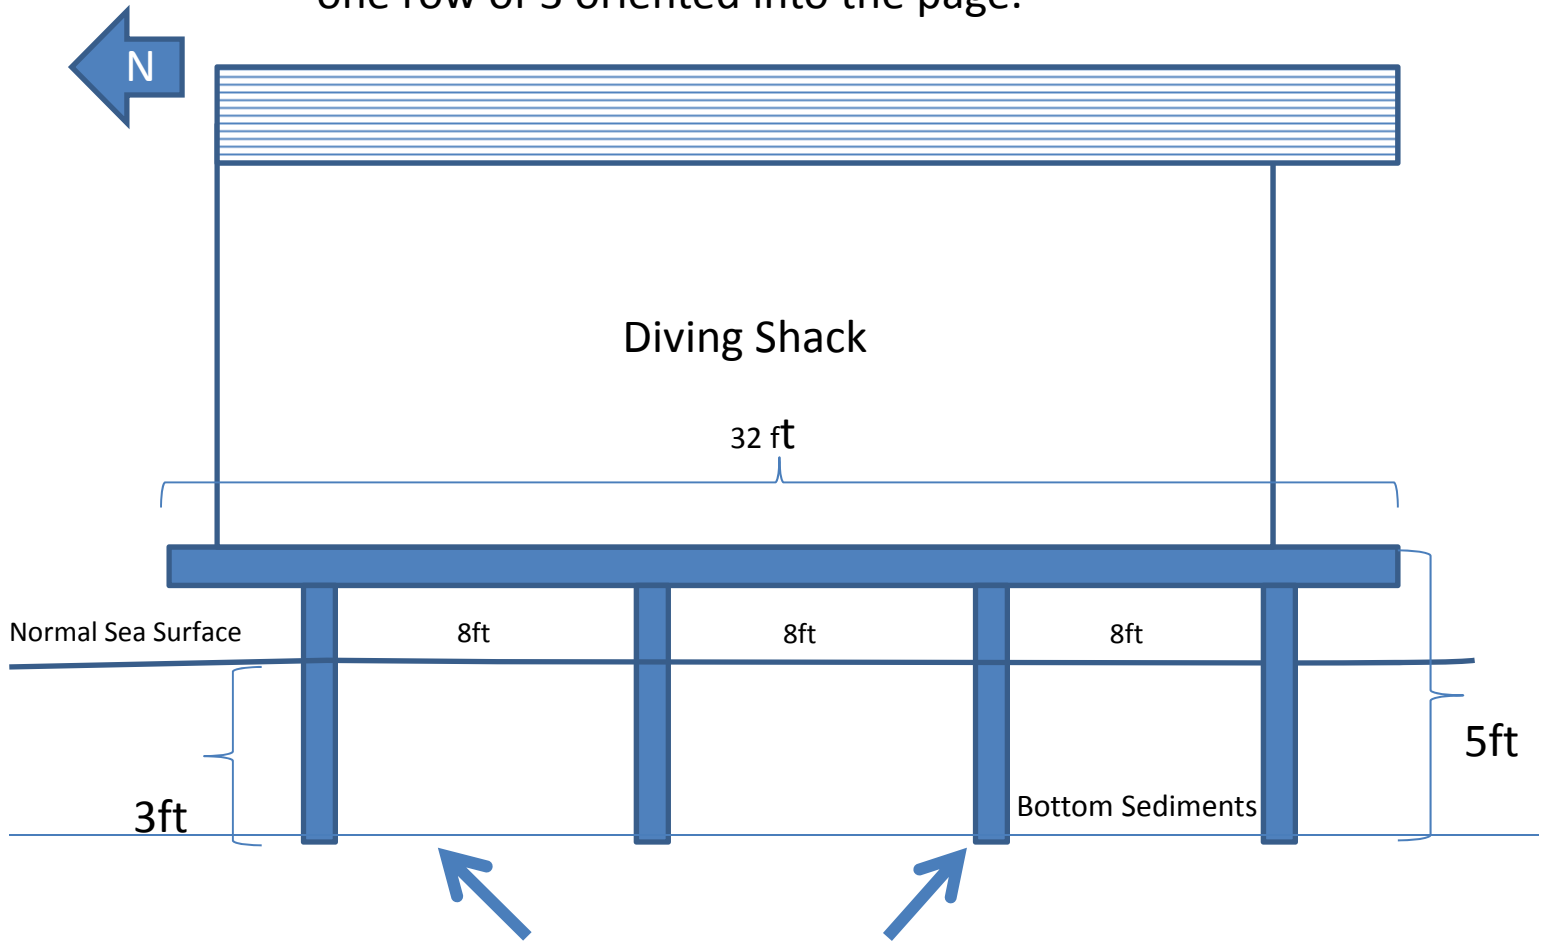
Side view D. Four pilings represent each one row of 3 oriented into the page.

Diagonal View to the Northeast Showing the deteriorated condition of cement pilings

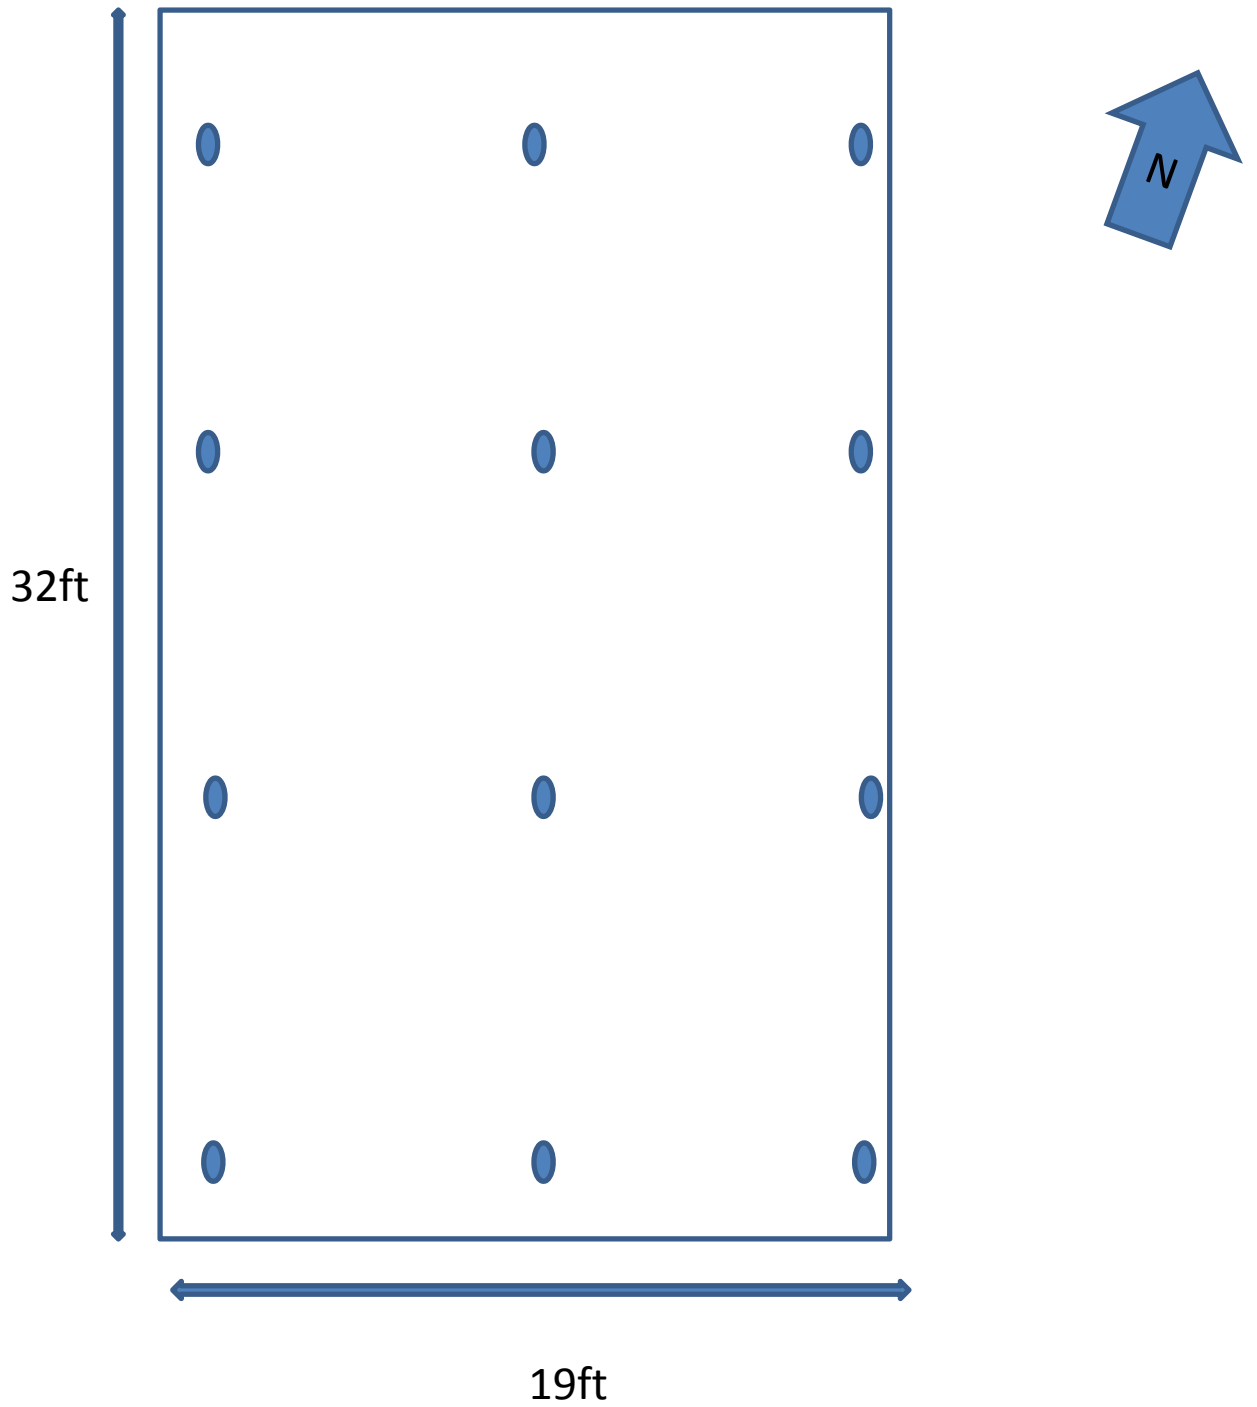
Top View Diving Shack at Dock G. The approximate locations of Pilings are shown
